STM32F042x4/x6 device limitations**Silicon identification**

This document applies to the part numbers of STM32F042x4/x6 devices listed in [Table 1](#) and their silicon revisions shown in [Table 2](#).

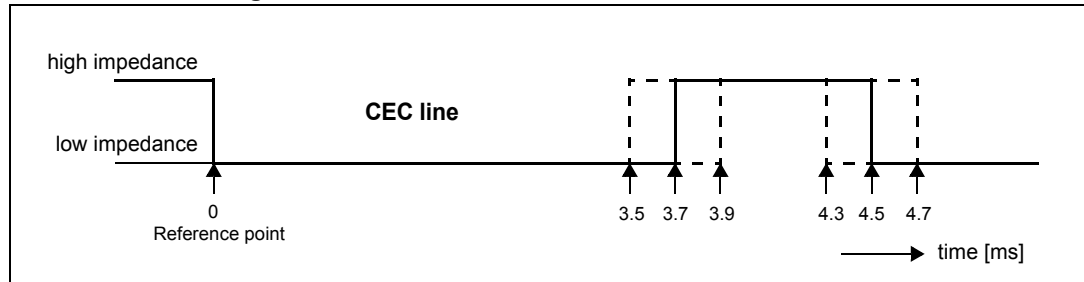
Figure 1. HDMI-CEC start bit format with tolerances

When the HDMI-CEC communication start bit transmitted by the device is corrupted by another device on the CEC line, the CEC transmission is stalled.

The start bit timing standard tolerances are shown in [Figure 1](#). The start bit is initiated by the device by driving the CEC line low (reference point). After 3.7 ms, the device releases the CEC line and starts checking its level. The following conditions must be met for the start bit to be valid:

- the CEC line goes high no later than 3.9 ms (4.05 ms with extended tolerance) from the reference point
- a falling edge on the CEC line does not occur earlier than 4.3 ms (4.15 ms with extended tolerance) from the reference point

If one of these conditions is not met, the transmission is aborted and never automatically retried. No error flag is set and the TXSOM (Tx Start Of Message) bit is not cleared.

A way to work this limitation around is for the system-level CEC application software to start a time-out counter when setting TXSOM bit and stop it upon TXBR or TXEND event. In case of time-out, the HDMI-CEC functional block is disabled then enabled, by setting the CECEN bit in CEC_CR register to 0 then to 1. This clears the TXSOM bit.
